## **MECHANICAL REPAIRS.**

## **BOTTOM MAIN AUGER BEARING SEAL INSPECTION, ADJUSTMENT OR REPLACEMENT**

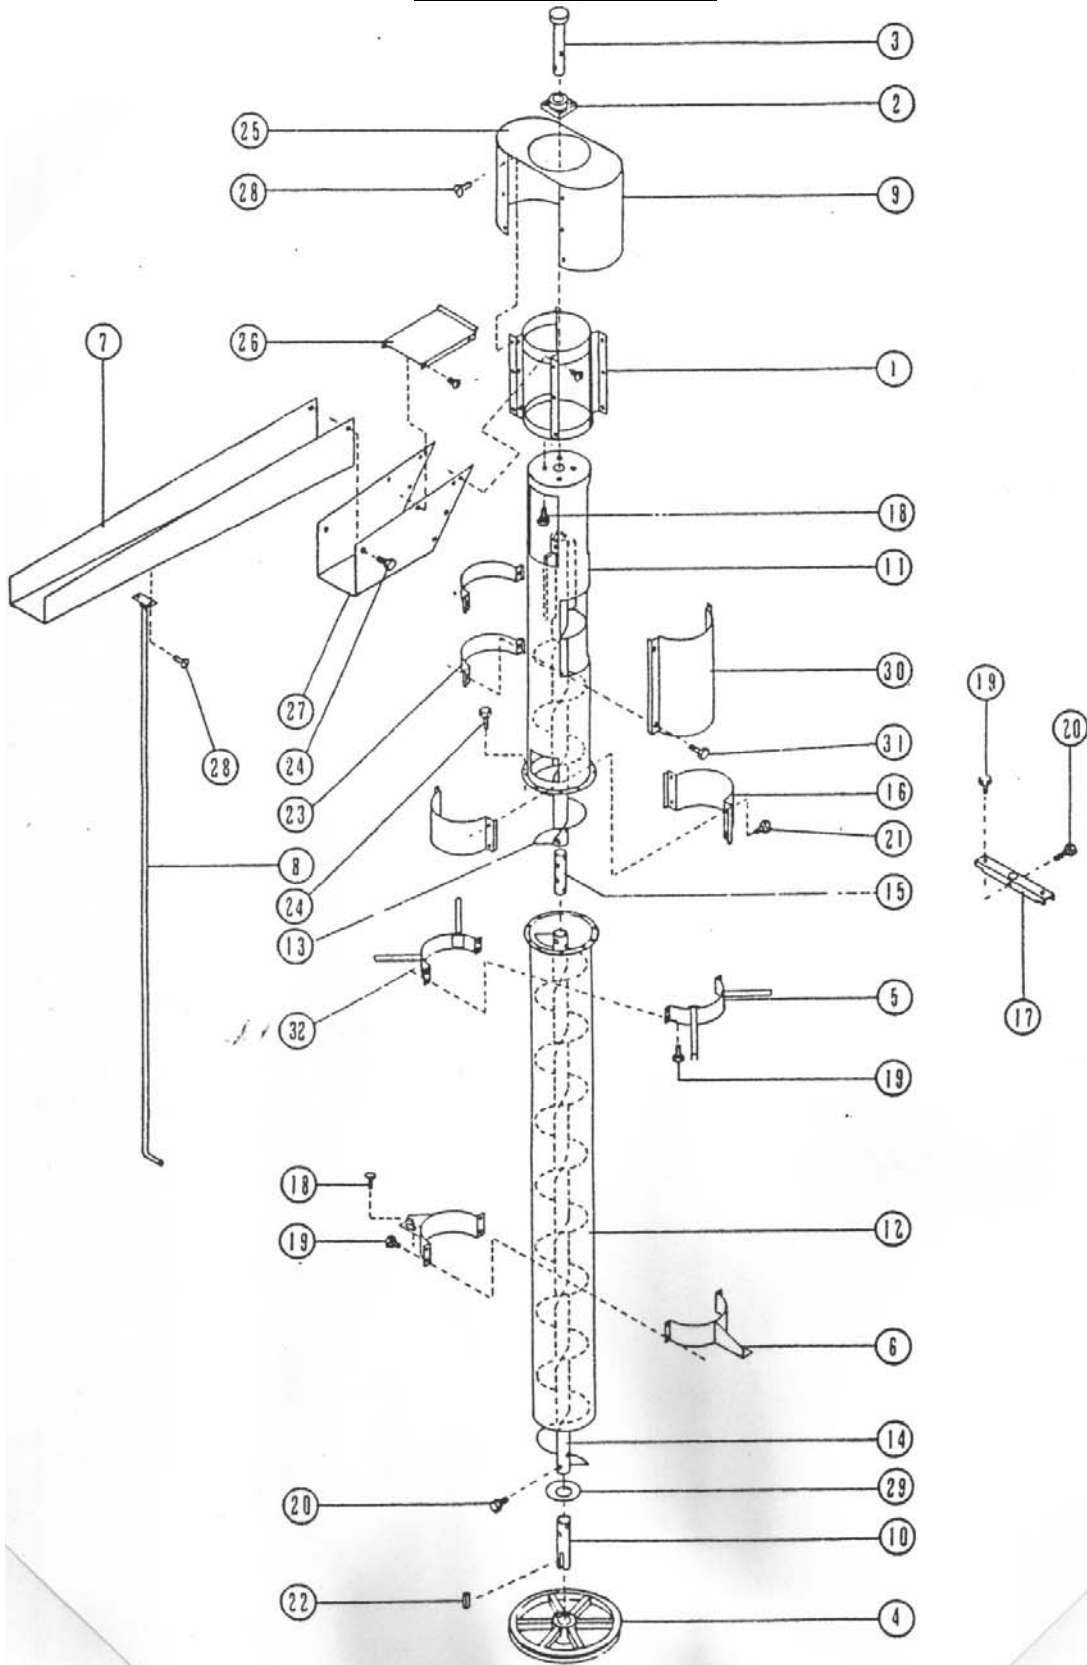
# AUGER ASSEMBLY

3. Loosen the locking collar on the bearing (2).
4. Remove the two 5/8" diameter bolts which go through the top of the auger shaft (13) and secure the upper stub shaft (3).

5. Remove the upper stub shaft (3).
6. Remove the four cup headed bolts which secure the bearings (2) to the auger tube (11).
7. Fit new bearing using new bolts and nuts if necessary. Do not tighten the bolts at this stage!

8. Grease and re-fit upper stub shaft (3) through bearing (2) and re-fit bolts through auger (13) tighten bolts securely (It may be necessary to jack the auger slightly to get the bolt holes to line up).

9. Center the auger (13) in the tube (11) and then tighten the bolts securing the bearing (2) to the auger tube (11).
10. Release the jack under the main auger and allow the auger to settle down into position, and then secure the bearing locking collar onto the upper stub shaft.

Refer to diagram on page 4.04

11. Check the bottom auger clearance and adjust as required. See diagram on page 4.04

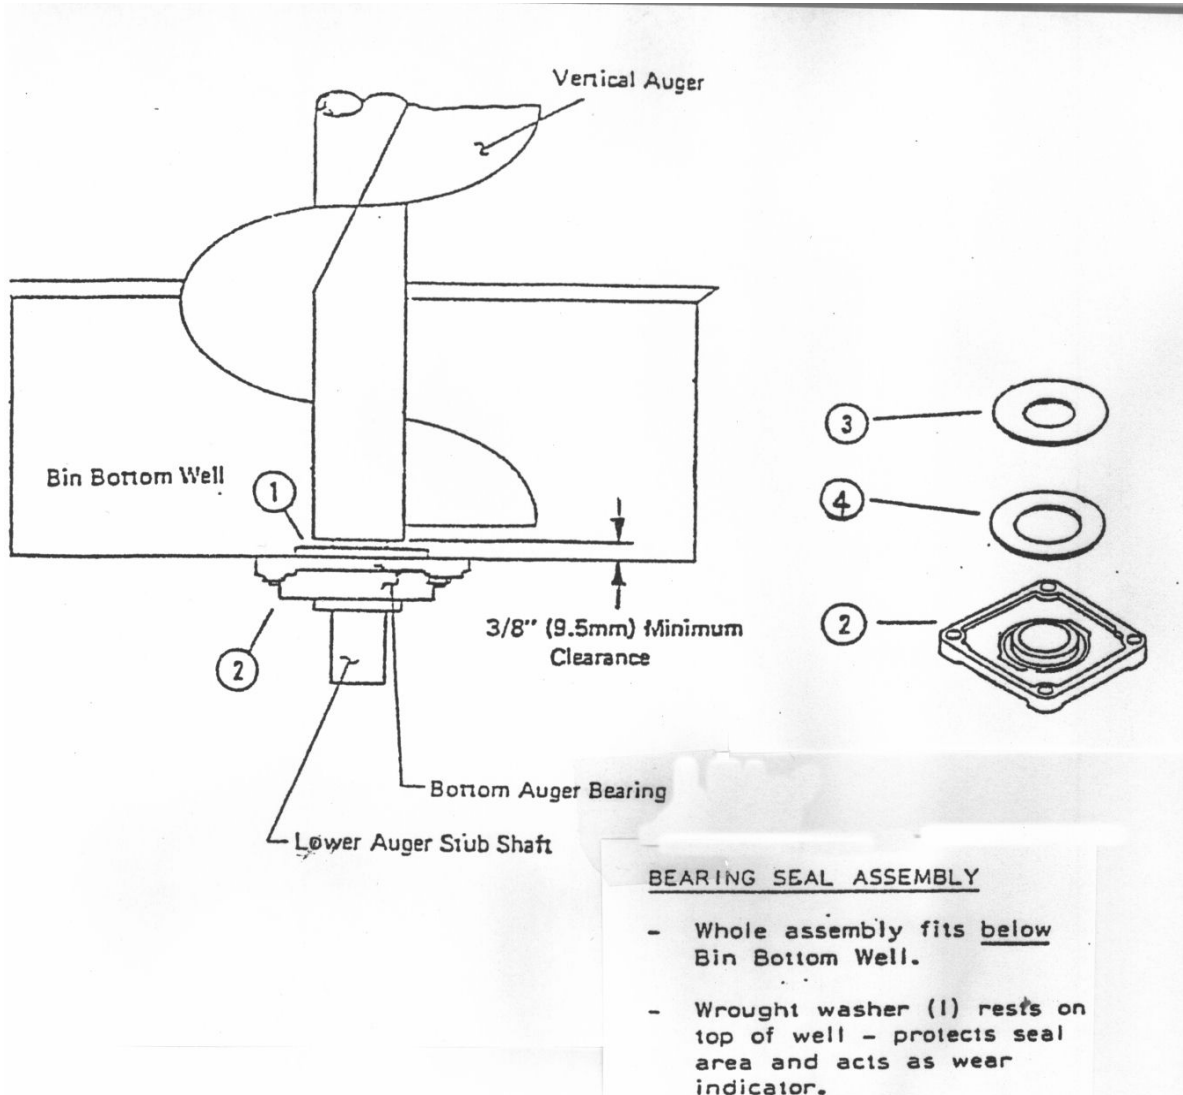
## BOTTOM MAIN AUGER BEARING & SEAL ASSEMBLY

9. Refitting. Lubricate and fill upper cavity with grease. Place Neoprene bearing seal (Key 4) over bearing collar (refer illustration) and centralize neoprene shaft seal over bearing center. Re-fit bearing (carriage bolt heads inside well) using lock washers – but leave nuts slack at this stage.

KEY	PART NO.	QTY.	ITEM
1	72424	1	2" Washer - Wrought
2	D21161	1	2" Bearing - Bottom Auger
3	73289	1	2" Seal - Shaft Neoprene
4	73290	1	2 22/32" Seal - bearing Neoprene

10. Place 2" wrought washer key 1) over stub shaft hole inside well. Grease and re-fit stub shaft up through bearing, seals, well and washer into vertical auger. Re-fit cap screws (as stage 7) and tighten bearing nuts (stage 9).
11. Re-fit 18" auger sheave – important – with allen screws uppermost. Tighten carefully and re-fit belt.
12. Re-adjust idler sheave assembly to tension belt.

1. Open clean-out door in bin bottom well and check if at least 3/8" (9.5mm) clearance exists between inside bottom of well and lower end of vertical auger flight shaft – as illustration. **If less than minimum clearance – complete all following steps.** If clearance satisfactory - omit steps 5 and 6.
2. Slacken idler sheave adjuster and roll main auger drive belt off 18" auger sheave (No 4) underneath bin bottom well.
3. Loosen allen screws in 18" sheave and remove from lower auger stub shaft (No 10) – complete with key (No 22).
4. Loosen locking collar of lower auger bearing.
5. Place hydraulic jack under lower auger stub shaft and raise auger and housing assembly until at least 3/8" clearance exists between flight shafts and bottom well.

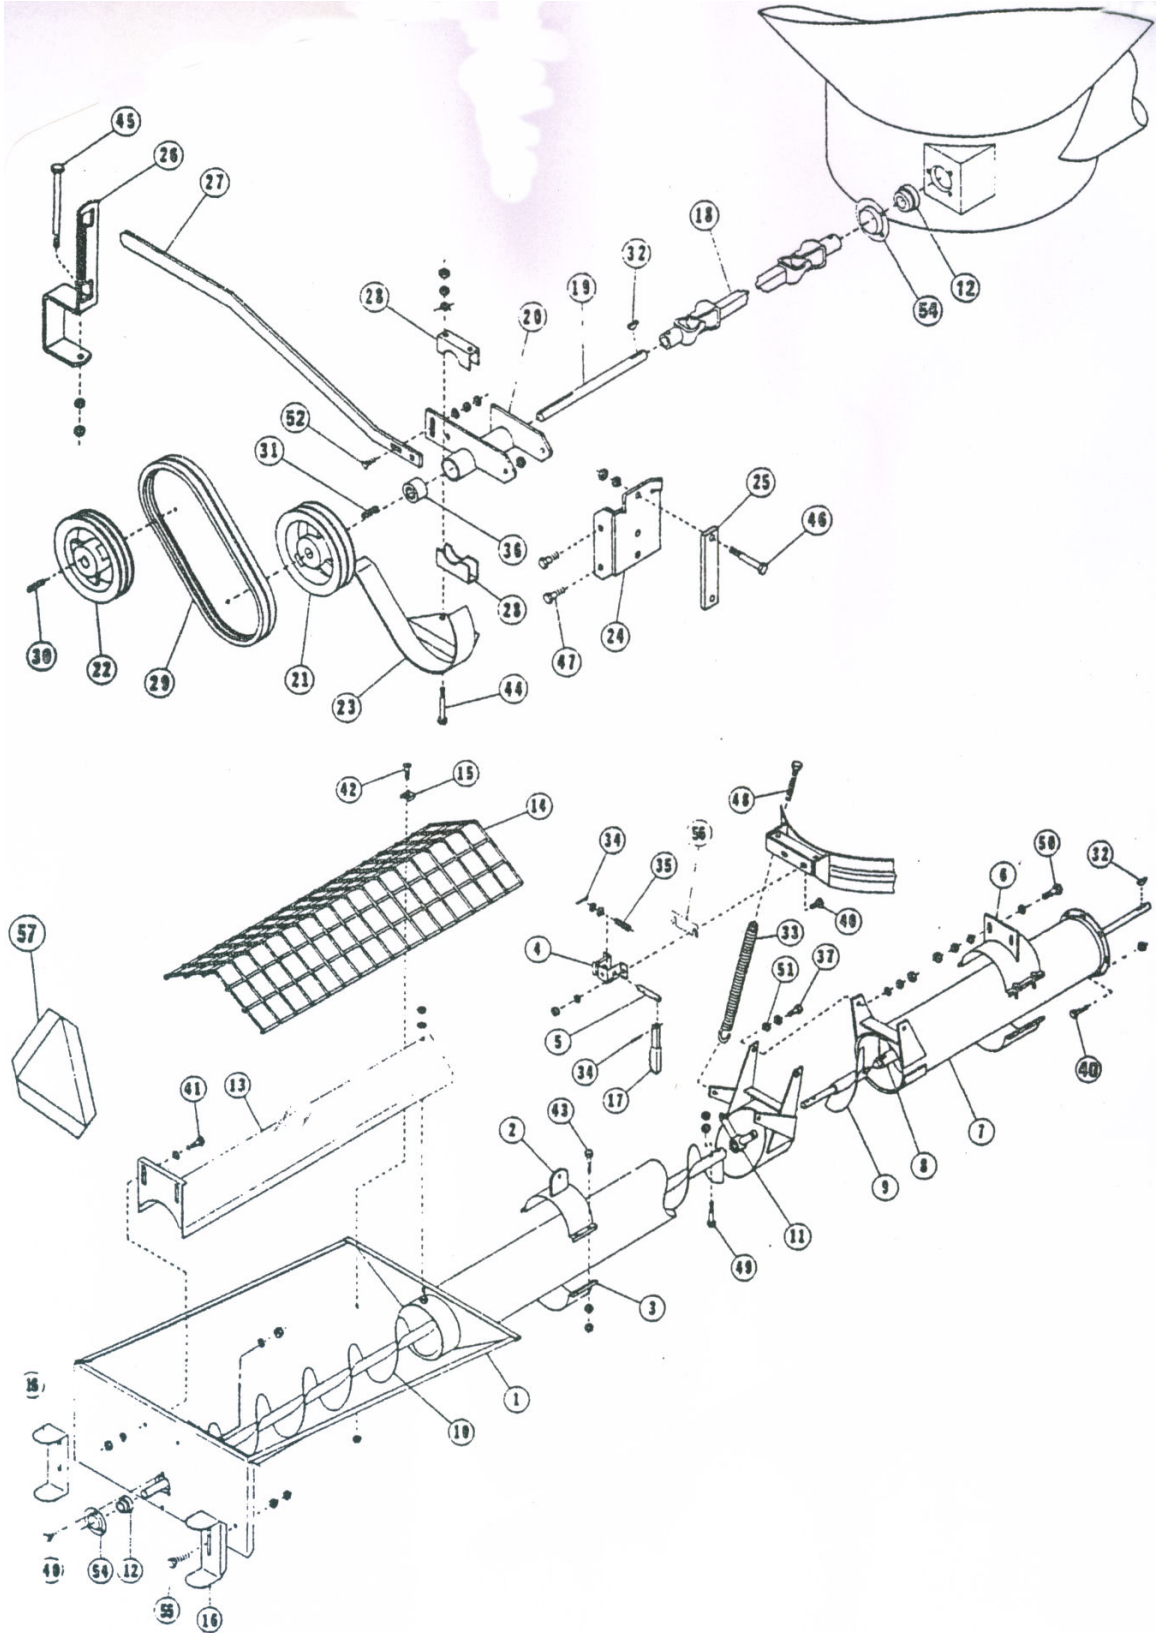
# LOADING HOPPER & DRIVE ASSEMBLY

1. Disconnect the PTO shaft from the tractor and lower the loading hopper into the working position.
2. Remove tumbler shaft from auger shaft end. Take care not to lose Woodruff key (32).

3. Loosen locking collar on bearing (12). Remove the three bolts securing the bearing to the bottom auger bin.
4. Remove the bearing flange (54) and slide the bearing off the shaft.

5. Remove remaining bearing flange and check both flanges for wear or damage. If in doubt, fit new.
6. Re-fit bearing flange (54) against bottom auger bin. Fit new bearing (12) and refit outer flange (54).

7. Bolts new bearing assembly to bottom auger bin. If bolt heads are worn, fit new bolts.
8. Set engagement of front auger (8) with rear auger (9) by pushing the front auger (8) rearwards as far as it will go, then pull forward  $\frac{1}{4}$ " (6mm). Once set, tighten the bearing locking collar onto the shaft.

9. Re-fit key (32) and tumbler shaft (18).

Refer to diagram on page 4.06

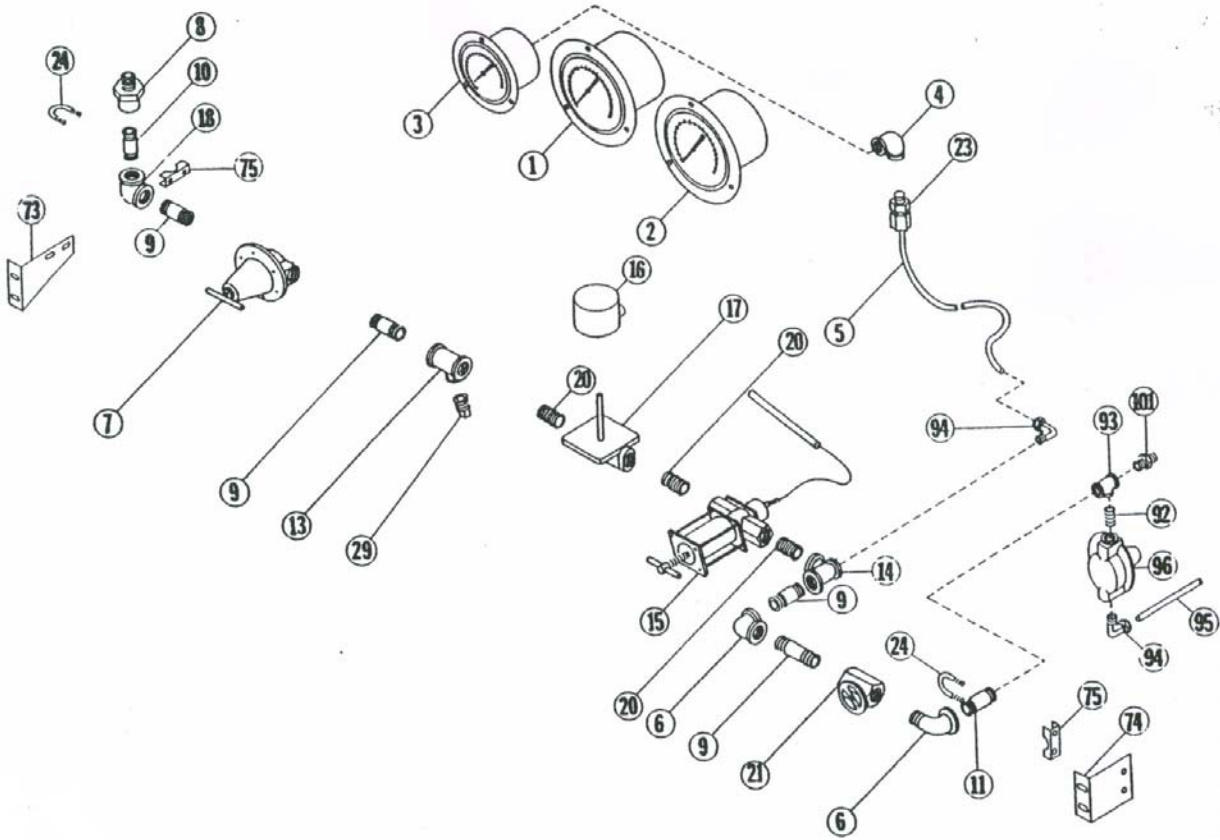
**VAPOR LINE PLUMBING**

The vapor line is the line between the vaporizer and the burner and contains the main gas controls. Access to it is through the large door on the left hand side of the burner unit. It needs to be removed for cleaning and/or dismantling.

2. Starting at the rear end of the line (pressure regulator end), undo the brass nut and remove the copper tube fitted to the adaptor No 8.
3. Remove the screw from the top of the vapor solenoid coil (16) and lift off the coil. On dryers fitted with a Microprocessor and models 545XL and 345XL, there are two vapor solenoids. It is important to mark the solenoid coils so they are refitted in the correct place. There is no need to disconnect the wires.

4. Non Microprocessor Dryers: Disconnect the temperature sensor bellows from the modulating valve (15). Release all pressure on the adjusting screw and then remove the four screws securing the bellows to the valve body. Carefully withdraw the bellows taking care not to lose the bellows reinforcing plate. (For details of modulating valve see page).

5. Disconnect pressure gauge tube (5) from adaptor (94) situated just after the modulating valve.
6. Disconnect pilot orifice tube (95) from pilot regulator (96).

7. Disconnect copper tube to burner from adaptor (101).
8. Remove handle from ball valve (21).
9. Remove nuts for "U" bolts (24) situated at each end of the line and remove "U" bolts (24) and clamping plates (75). Remove the vapor line to a bench for further work. It may assist removal of the line if the adjusting screws are removed from the pressure regulator (and the modulating valve if fitted).

See diagrams on page 4.08

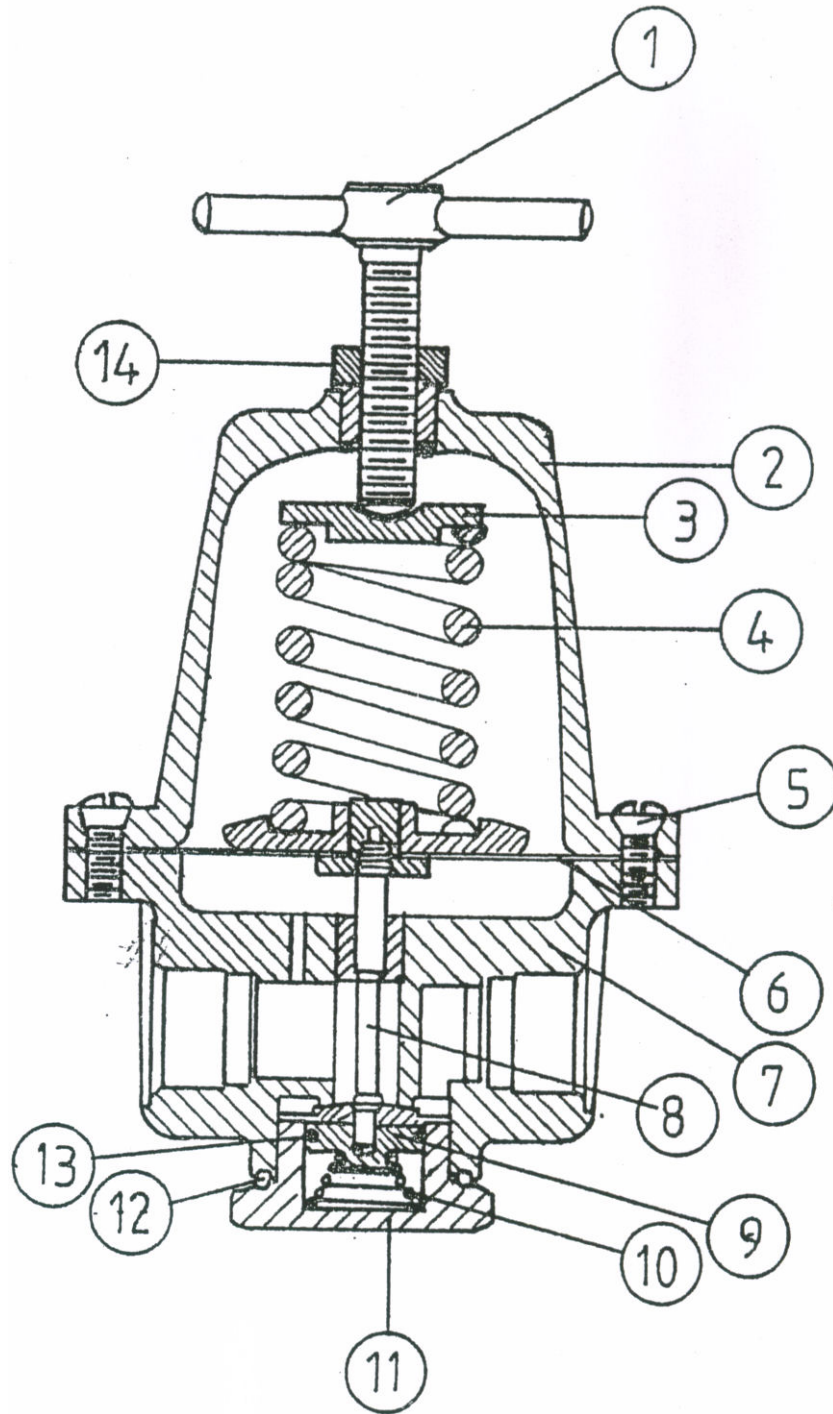
**PRESSURE REGULATOR**

3. Unscrew the large hexagon nut (11) at the rear of the regulator, taking care not to lose the seal (12) or the spring (10).
4. The plunger (9) may be stuck in the hollow part of the nut (11), in which case it will be necessary to carefully remove it. (Take care not to lose the spring).

5. Clean all the parts thoroughly, not forgetting the small hole drilled in the threaded wall of the hollow nut.
6. Place the nut (11), hollow part uppermost on a solid surface. Place the spring (10), narrow end uppermost inside the nut. Place the plunger (9) with the small threaded hole uppermost on top of the spring (10) and press down until the plunger (9) is inside the nut (11). Once inside, release the pressure and allow the spring (10) to push the plunger (9) out. If the spring (10) cannot easily push the plunger (9) out of the nut (11), it will be necessary to take a sharp knife and trim the top off the "O" ring (13) that is fitted around the plunger. Repeat above until plunger (9) moves freely in and out of the nut. Do not apply oil to the "O" ring; if necessary apply a small amount of silicone lubricant.

7. Screw the plunger (9) back onto the threaded rod (8) in the rear of the regulator.
8. Make sure the seal (12) is properly fitted in its groove in the nut (11).
9. Fit the spring (10) into the nut (11) narrow end outwards and screw the nut back into the regulator.

See diagram 4.11

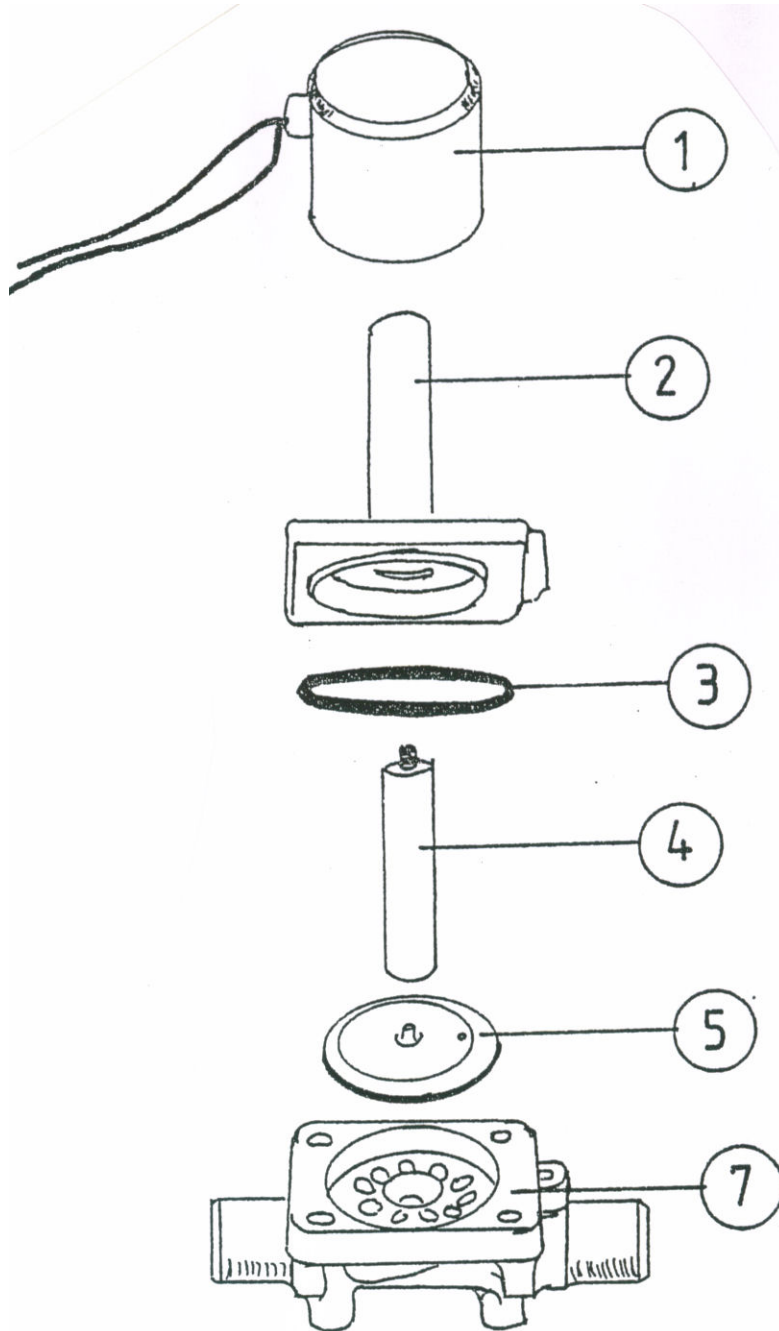
# SOLENOID VALVE

The dryer will be equipped with either 2 or 3 solenoid valves depending on the model and age. One solenoid is used to control the liquid gas flow and one or two are used to control the vapor flow. Where two solenoids are used to control the vapor flow, one controls the low heat, and one the high heat. The low heat solenoid is fitted with a control orifice and care should be taken to ensure that the orifice plug is clean and secure.

To dismantle the solenoid, first remove the screw from the top and lift off the electrical coil (1). If two solenoids are to be cleaned, mark each coil to ensure they are re-fitted in the same position.

Next remove the four socket head screws from the base of the solenoid body (the top (2) will be pushed up by pressure from the plunger spring), then carefully lift off the top (2) taking care not to lose the “O” ring (3) or the plunger (4). Next lift off the diaphragm (5) noting which way it is fitted. (The diaphragm is usually marked to show which way it should be but it is not always easy to read).

Clean all parts thoroughly, inspect “O” ring (3) and diaphragm for signs of wear or damage, if at all suspect fit new parts. When re-assembling, place diaphragm on solenoid body (7) ensuring it is the correct way up. Hold the solenoid top section (2) upside down and put the plunger (4) back into the center. Before fitting plunger (4) make sure the spring is still fixed in the top. This end should go in first. Next fit “O” ring (3) to the top section (2) and re-fit to the base (7) using the four socket head screws. Tighten the screws fully but first ensure that the diaphragm (5) and “O” ring (3) are not likely to get damaged.

Propane Gas Dryers – Refer to diagram 4.13:

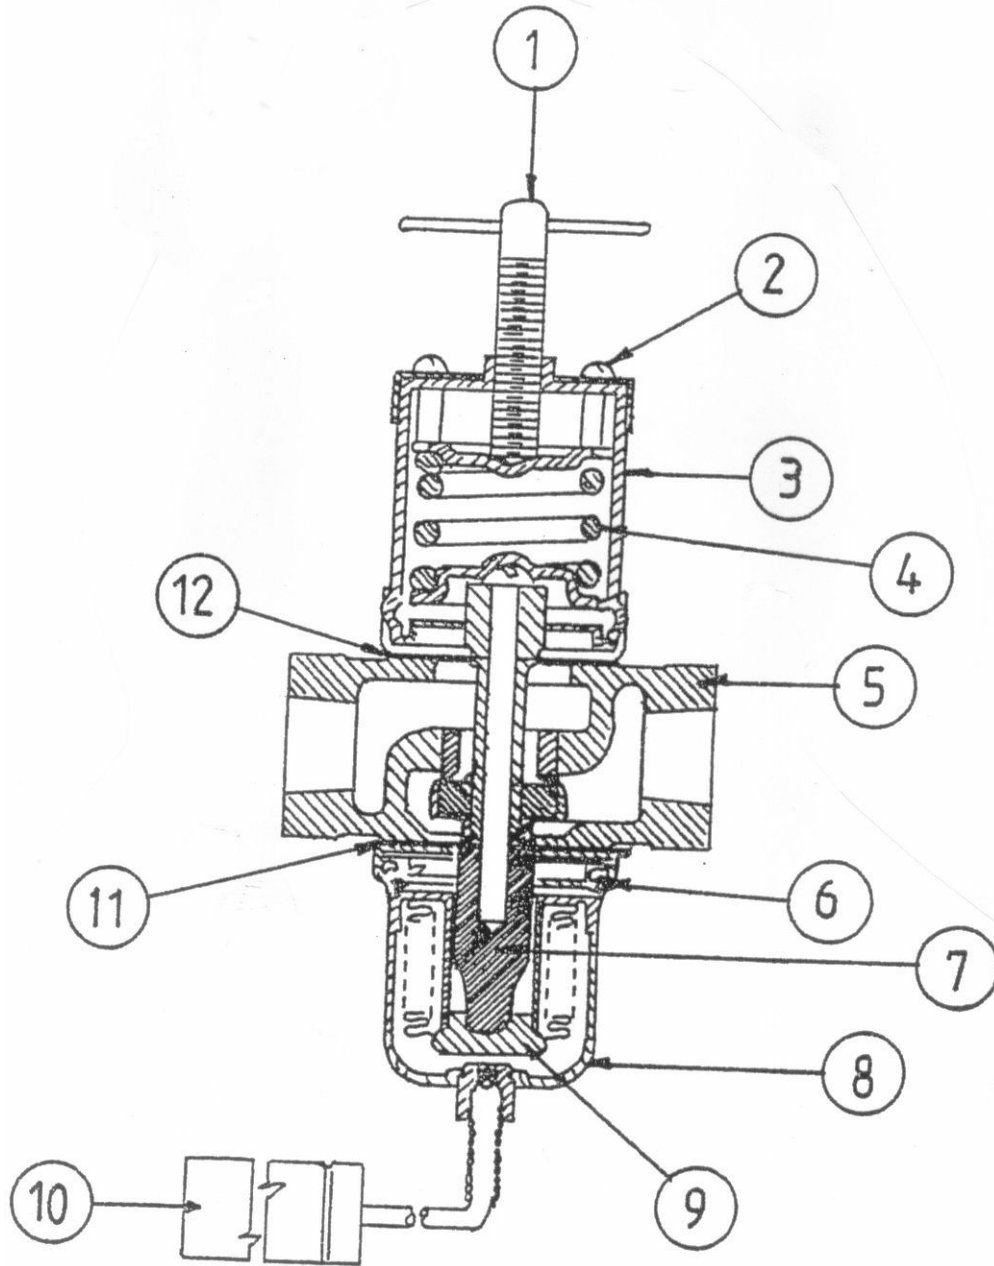
**MODULATING VALVE**

The power element (10) usually needs to be replacing when it is not possible to control the heat of the dryer with the modulating valve.

Remove the four screws which secure the power element bellows (8) and carefully withdraw the bellows from the main body of the valve. Take care not to lose the reinforcing plate (9).

Fit the bellows (8) of the new power element to the main body of the valve, ensuring that the reinforcing plate (9) is in position. Carefully thread the power element sensor and tube through the tube into the plenum chamber and fit the new sensor into the bracket and secure it to the frame. Carefully coil up and/or secure any excess capillary tube so it cannot get accidentally damaged.

To reset the valve, screw in the adjusting screw (1) until pressure is felt the screw in a further 4 full turns. Make the final adjustment with the burner running.

Start the dryer and ignite the burner in the usual way, once the plenum temperature has started to raise the pressure gauge reading should start to drop. Once the temperature and pressure gauge readings appear to have stabilized, it is possible to check the operation of the valve by making a sudden adjustment of  $\frac{1}{4}$  to  $\frac{1}{2}$  a turn on the adjusting screw (1) either way. This should cause a fall or rise in the pressure gauge reading.
