MECHANICAL REPAIRS.

BOTTOM MAIN AUGER BEARING INSPECTION, ADJUSTMENT OR REPLACEMENT.	4.02 - 4.05
REPLACING TOP MAIN AUGER BEARING.	4.05
REPLACING INTAKE AUGER FRONT BEARING.	4.06 - 4.07
REMOVING THE VAPOUR LINE.	4.07 – 4.09
CLEAN THE PRESSURE REGULATOR DAMPER.	4.10 – 4.11
DISMANTLE AND CLEAN SOLENOID VALVE.	4.12 – 4.13
MODULATING VALVE POWER ELEMENT REPLACEMENT.	4.14 – 4.15
PROBLEM SOLVING MECHANICAL.	4.16 – 4.21

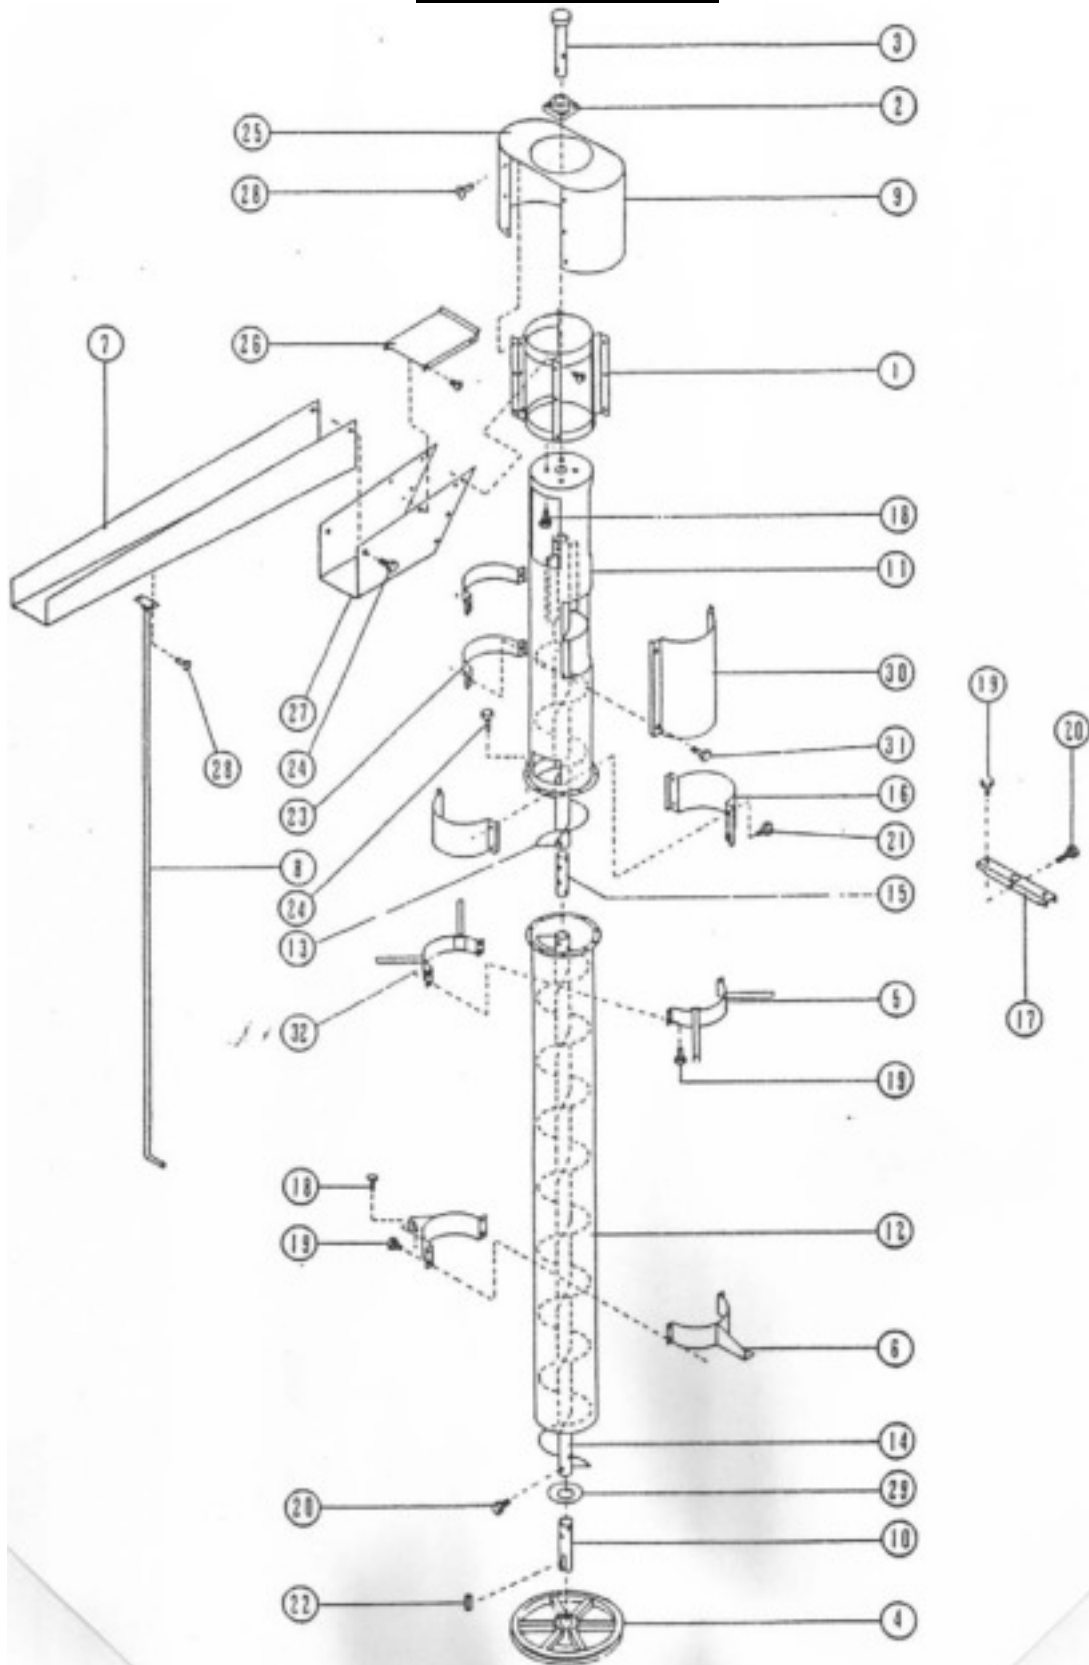
AUGER ASSEMBLY

4.03

REPLACING TOP MAIN AUGER BEARING:

Refer to diagram on page 4.04

1. Place a jack or similar device under the bottom of the main auger to support the weight of the auger.
2. It is advisable to put a pallet and/or strong wooden boards across the top of the dryer to stand on.

3. Loosen the locking collar on the bearing (2).
4. Remove the two 5/8" diameter bolts which go through the top of the auger shaft (13) and secure the upper stub shaft (3).

5. Remove the upper stub shaft (3).
6. Remove the four cup headed bolts which secure the bearings (2) to the auger tube (11).
7. Fit new bearing using new bolts and nuts if necessary. Do not tighten the bolts at this stage!

8. Grease and re-fit upper stub shaft (3) through bearing (2) and re-fit bolts through auger (13) tighten bolts securely (It may be necessary to jack the auger slightly to get the bolt holes to line up).

9. Center the auger (13) in the tube (11) and then tighten the bolts securing the bearing (2) to the auger tube (11).
10. Release the jack under the main auger and allow the auger to settle down into position, and then secure the bearing locking collar onto the upper stub shaft.

11. Check the bottom auger clearance and adjust as required. See diagram on page 4.04

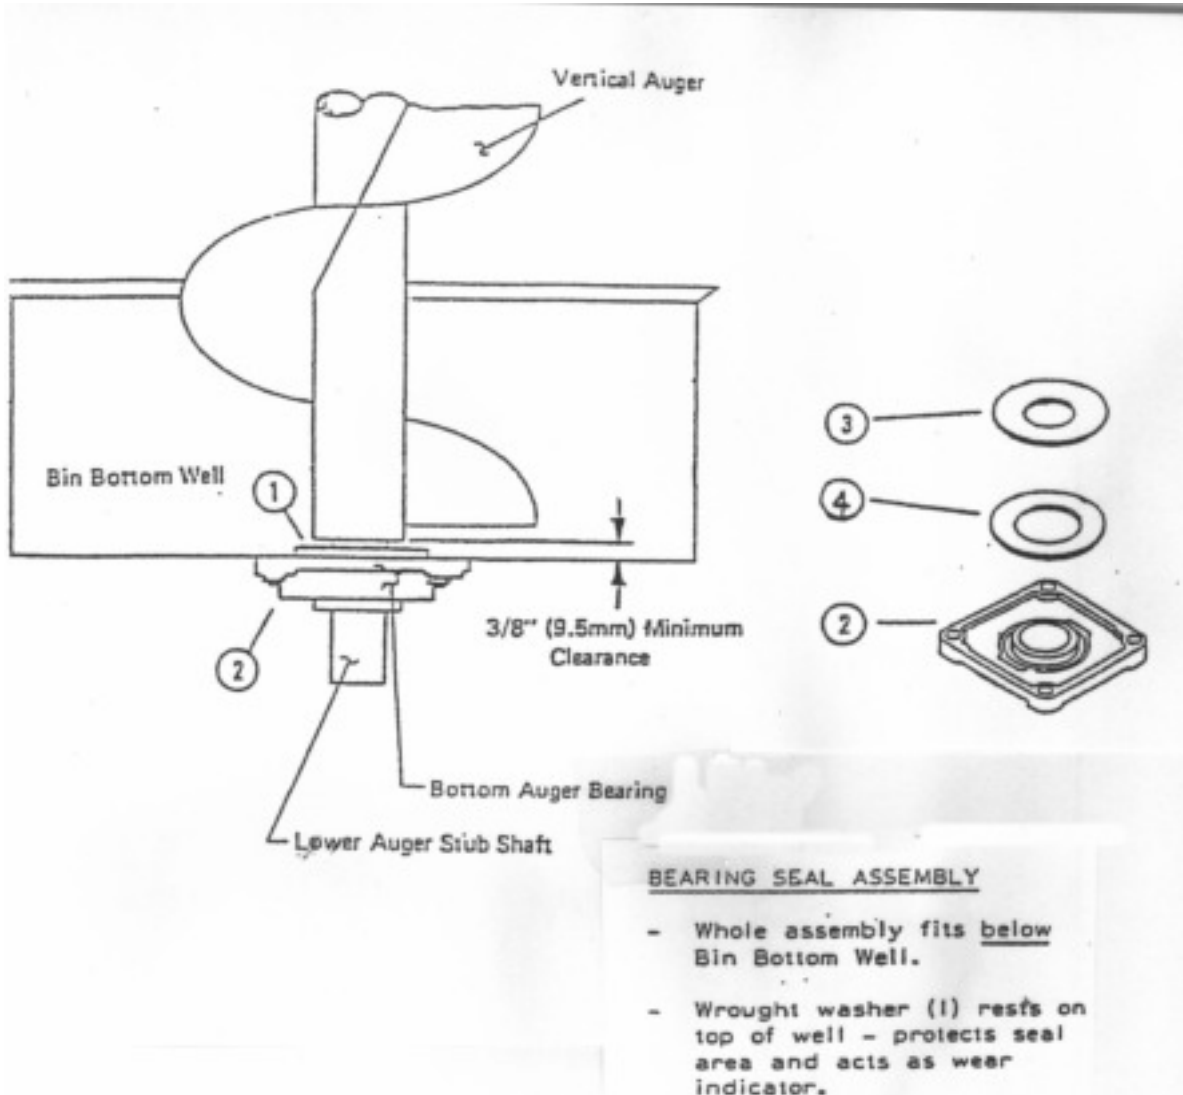
BOTTOM MAIN AUGER BEARING & SEAL ASSEMBLY

KEY	PART NO.	QTY.	ITEM
1	72424	1	2" Washer - Wrough
2	D21161	1	2" Bearing - Bottom Auger
3	73289	1	2" Seal - Shaft Neoprene
4	73290	1	2 22/32" Seal - bearing Neoprene

1. Open clean-out door in bin bottom well and check if at least 3/8" (9.5mm) clearance exists between inside bottom of well and lower end of vertical auger flight shaft – as illustration. **If less than minimum clearance – complete all following steps.** If clearance satisfactory - omit steps 5 and 6.
2. Slacken idler sheave adjuster and roll main auger drive belt off 18" auger sheave (No 4) underneath bin bottom well.
3. Loosen allen screws in 18" sheave and remove from lower auger stub shaft (No 10) – complete with key (No 22).
4. Loosen locking collar of lower auger bearing.
5. Place hydraulic jack under lower auger stub shaft and raise auger and housing assembly until at least 3/8" clearance exists between flight shafts and bottom well.

9. Refitting. Lubricate and fill upper cavity with grease. Place Neoprene bearing seal (Key 4) over bearing collar (refer illustration) and centralize neoprene shaft seal over bearing center. Re-fit bearing (carriage bolt heads inside well) using lock washers – but leave nuts slack at this stage.

10. Place 2" wrought washer key 1) over stub shaft hole inside well. Grease and re-fit stub shaft up through bearing, seals, well and washer into vertical auger. Re-fit cap screws (as stage 7) and tighten bearing nuts (stage 9).
11. Re-fit 18" auger sheave – important – with allen screws uppermost. Tighten carefully and re-fit belt.
12. Re-adjust idler sheave assembly to tension belt.

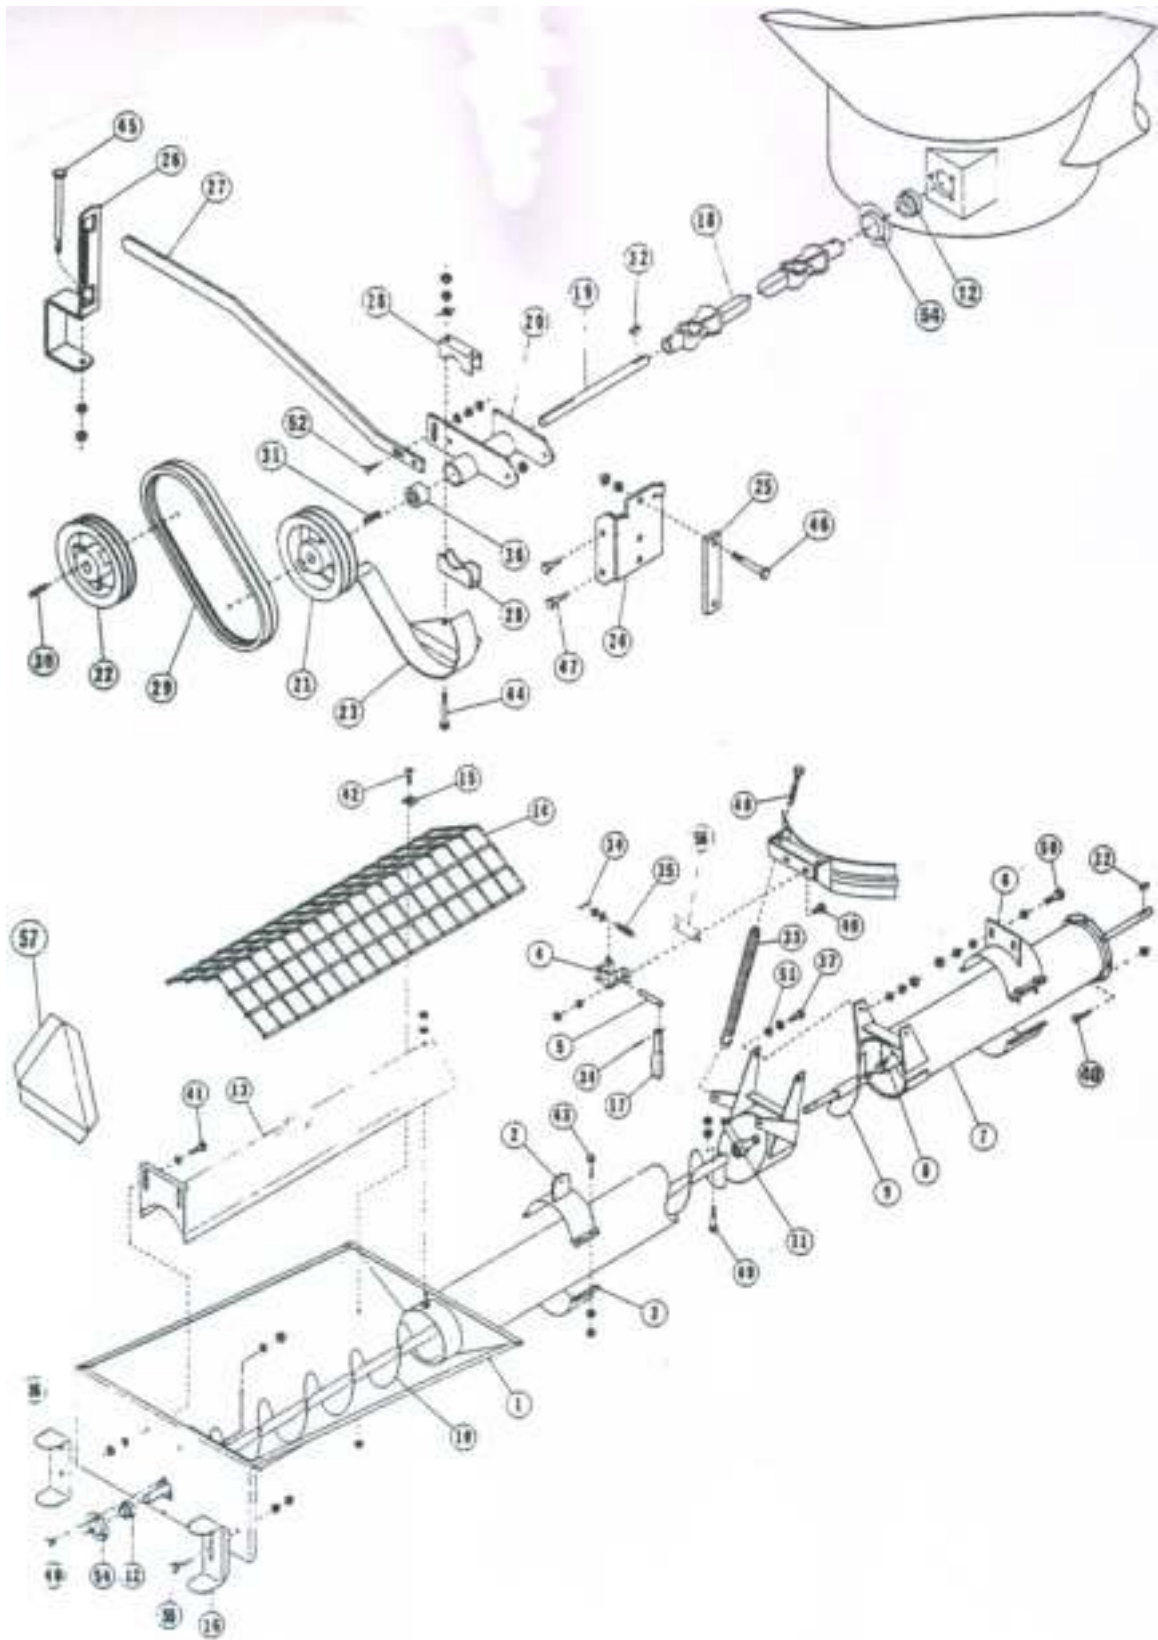
LOADING HOPPER & DRIVE ASSEMBLY

4.06

REPLACING THE INTAKE AUGER FRONT BEARING.

Refer to diagram on page 4.06

1. Disconnect the PTO shaft from the tractor and lower the loading hopper into the working position.
2. Remove tumbler shaft from auger shaft end. Take care not to lose Woodruff key (32).

3. Loosen locking collar on bearing (12). Remove the three bolts securing the bearing to the bottom auger bin.
4. Remove the bearing flange (54) and slide the bearing off the shaft.

5. Remove remaining bearing flange and check both flanges for wear or damage. If in doubt, fit new.
6. Re-fit bearing flange (54) against bottom auger bin. Fit new bearing (12) and refit outer flange (54).

7. Bolts new bearing assembly to bottom auger bin. If bolt heads are worn, fit new bolts.
8. Set engagement of front auger (8) with rear auger (9) by pushing the front auger (8) rearwards as far as it will go, then pull forward ¼" (6mm). Once set, tighten the bearing locking collar onto the shaft.

9. Re-fit key (32) and tumbler shaft (18).

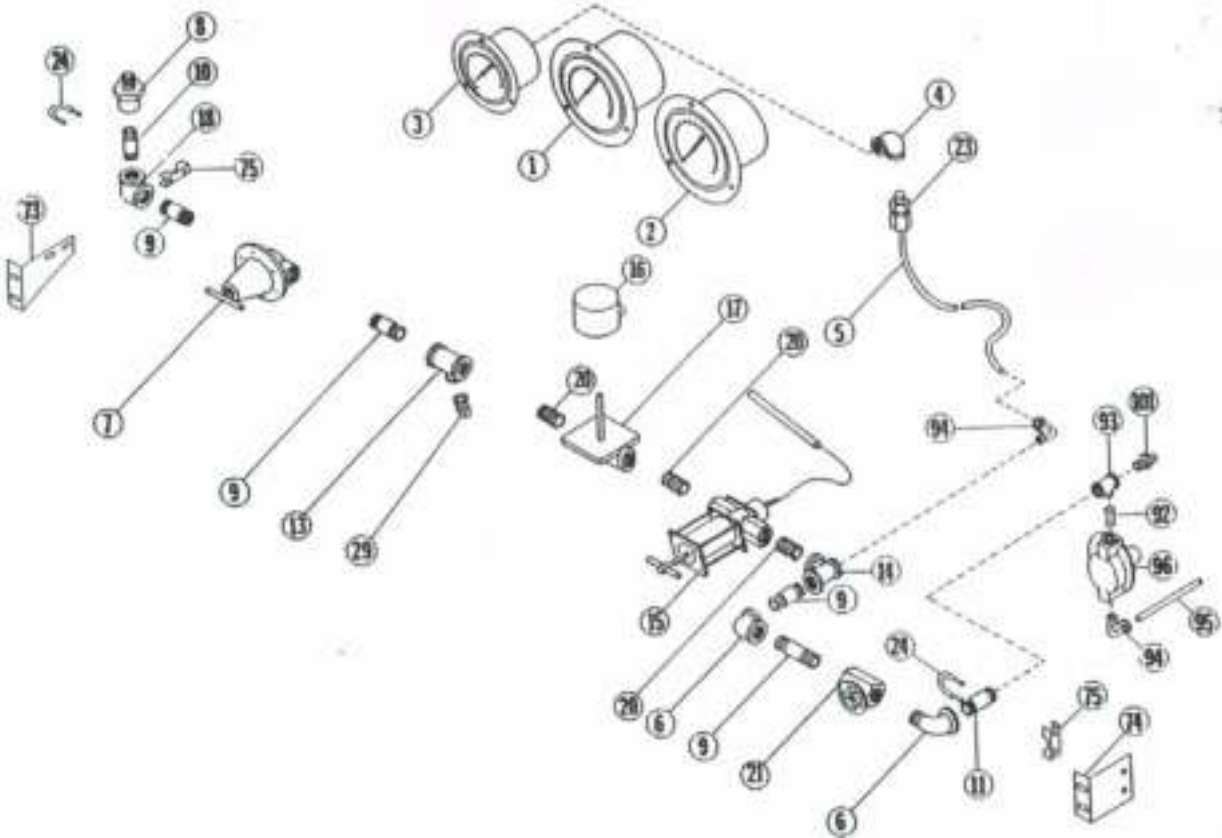
VAPOR LINE PLUMBING

The vapor line is the line between the vaporizer and the burner and contains the main gas controls. Access to it is through the large door on the left hand side of the burner unit. It needs to be removed for cleaning and/or dismantling.

2. Starting at the rear end of the line (pressure regulator end), undo the brass nut and remove the copper tube fitted to the adaptor No 8.
3. Remove the screw from the top of the vapor solenoid coil (16) and lift off the coil. On dryers fitted with a Microprocessor and models 545XL and 345XL, there are two vapor solenoids. It is important to mark the solenoid coils so they are refitted in the correct place. There is no need to disconnect the wires.

4. Non Microprocessor Dryers: Disconnect the temperature sensor bellows from the modulating valve (15). Release all pressure on the adjusting screw and then remove the four screws securing the bellows to the valve body. Carefully withdraw the bellows taking care not to lose the bellows reinforcing plate. (For details of modulating valve see page).

5. Disconnect pressure gauge tube (5) from adaptor (94) situated just after the modulating valve.
6. Disconnect pilot orifice tube (95) from pilot regulator (96).

7. Disconnect copper tube to burner from adaptor (101).
8. Remove handle from ball valve (21).
9. Remove nuts for "U" bolts (24) situated at each end of the line and remove "U" bolts (24) and clamping plates (75). Remove the vapor line to a bench for further work. It may assist removal of the line if the adjusting screws are removed from the pressure regulator (and the modulating valve if fitted).

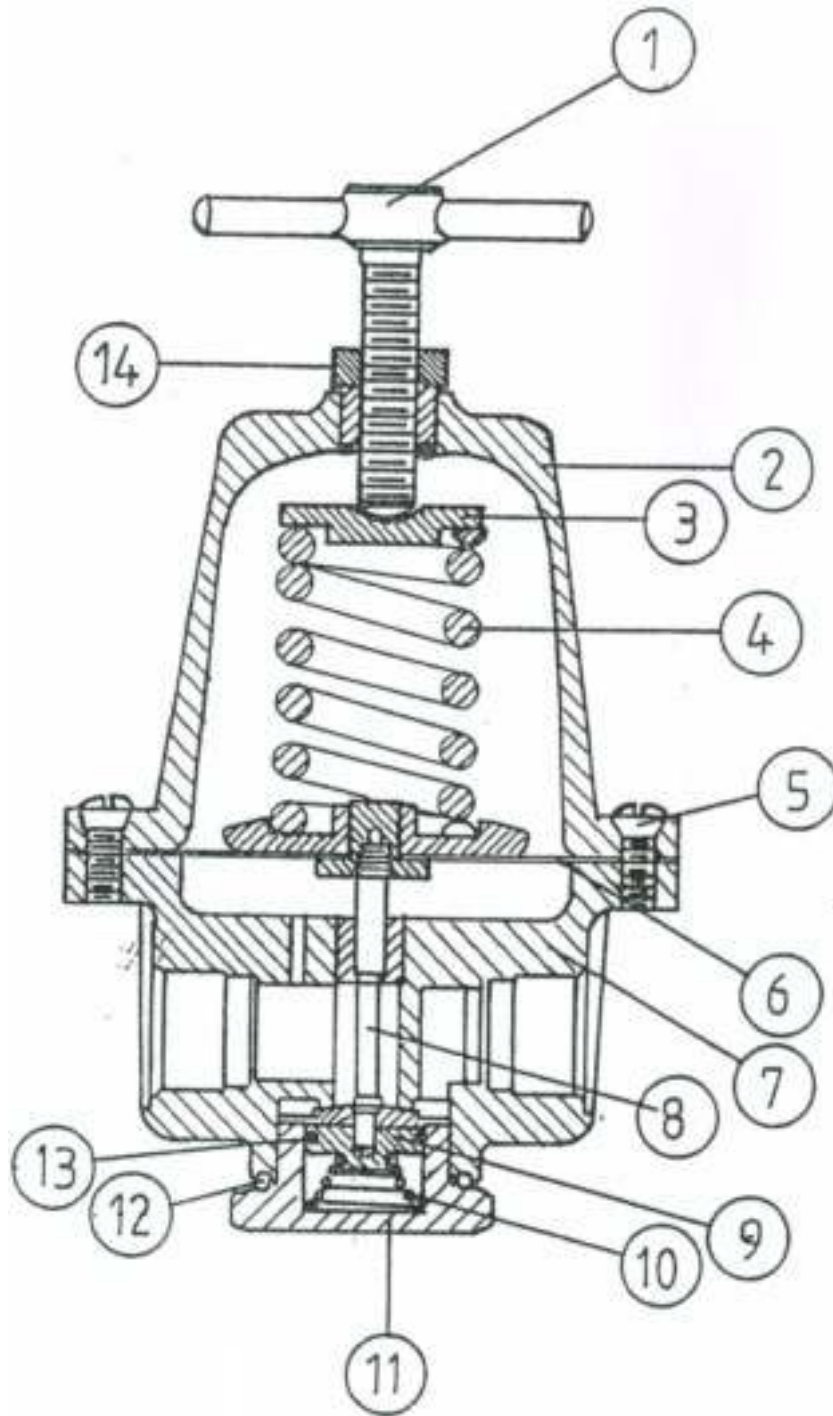
3. Unscrew the large hexagon nut (11) at the rear of the regulator, taking care not to lose the seal (12) or the spring (10).
4. The plunger (9) may be stuck in the hollow part of the nut (11), in which case it will be necessary to carefully remove it. (Take care not to lose the spring).

5. Clean all the parts thoroughly, not forgetting the small hole drilled in the threaded wall of the hollow nut.
6. Place the nut (11), hollow part uppermost on a solid surface. Place the spring (10), narrow end uppermost inside the nut. Place the plunger (9) with the small threaded hole uppermost on top of the spring (10) and press down until the plunger (9) is inside the nut (11). Once inside, release the pressure and allow the spring (10) to push the plunger (9) out. If the spring (10) cannot easily push the plunger (9) out of the nut (11), it will be necessary to take a sharp knife and trim the top off the "O" ring (13) that is fitted around the plunger. Repeat above until plunger (9) moves freely in and out of the nut. Do not apply oil to the "O" ring; if necessary apply a small amount of silicone lubricant.

7. Screw the plunger (9) back onto the threaded rod (8) in the rear of the regulator.
8. Make sure the seal (12) is properly fitted in its groove in the nut (11).
9. Fit the spring (10) into the nut (11) narrow end outwards and screw the nut back into the regulator.

PROCEDURE TO CLEAN THE PRESSURE REGULATOR DAMPER:

See diagram 4.11

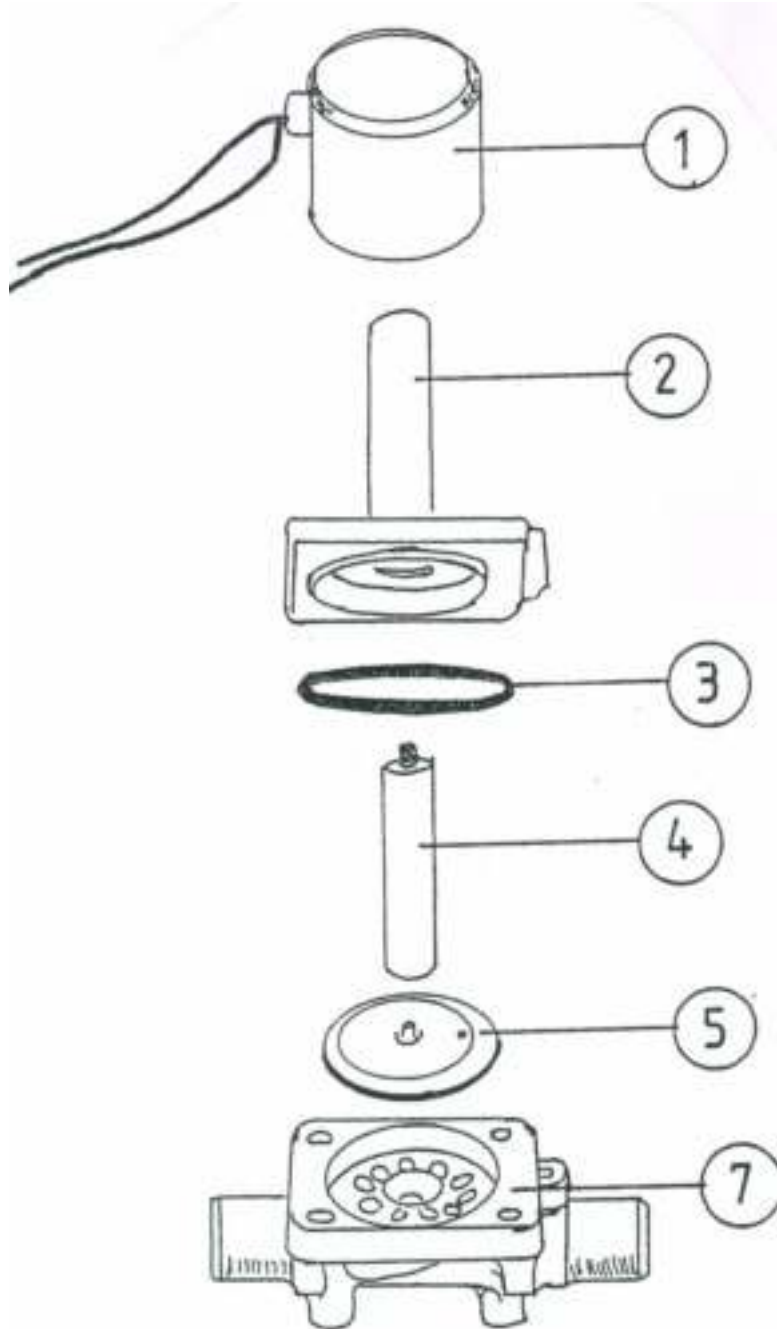
SOLENOID VALVE

The dryer will be equipped with either 2 or 3 solenoid valves depending on the model and age. One solenoid is used to control the liquid gas flow and one or two are used to control the vapor flow. Where two solenoids are used to control the vapor flow, one controls the low heat, and one the high heat. The low heat solenoid is fitted with a control orifice and care should be taken to ensure that the orifice plug is clean and secure.

To dismantle the solenoid, first remove the screw from the top and lift off the electrical coil (1). If two solenoids are to be cleaned, mark each coil to ensure they are re-fitted in the same position.

Next remove the four socket head screws from the base of the solenoid body (the top (2) will be pushed up by pressure from the plunger spring), then carefully lift off the top (2) taking care not to lose the “O” ring (3) or the plunger (4). Next lift off the diaphragm (5) noting which way it is fitted. (The diaphragm is usually marked to show which way it should be but it is not always easy to read).

Clean all parts thoroughly, inspect “O” ring (3) and diaphragm for signs of wear or damage, if at all suspect fit new parts. When re-assembling, place diaphragm on solenoid body (7) ensuring it is the correct way up. Hold the solenoid top section (2) upside down and put the plunger (4) back into the center. Before fitting plunger (4) make sure the spring is still fixed in the top. This end should go in first. Next fit “O” ring (3) to the top section (2) and re-fit to the base (7) using the four socket head screws. Tighten the screws fully but first ensure that the diaphragm (5) and “O” ring (3) are not likely to get damaged.

DISMANTLE AND CLEAN SOLENOID VALVE:

Propane Gas Dryers – Refer to diagram 4.13:

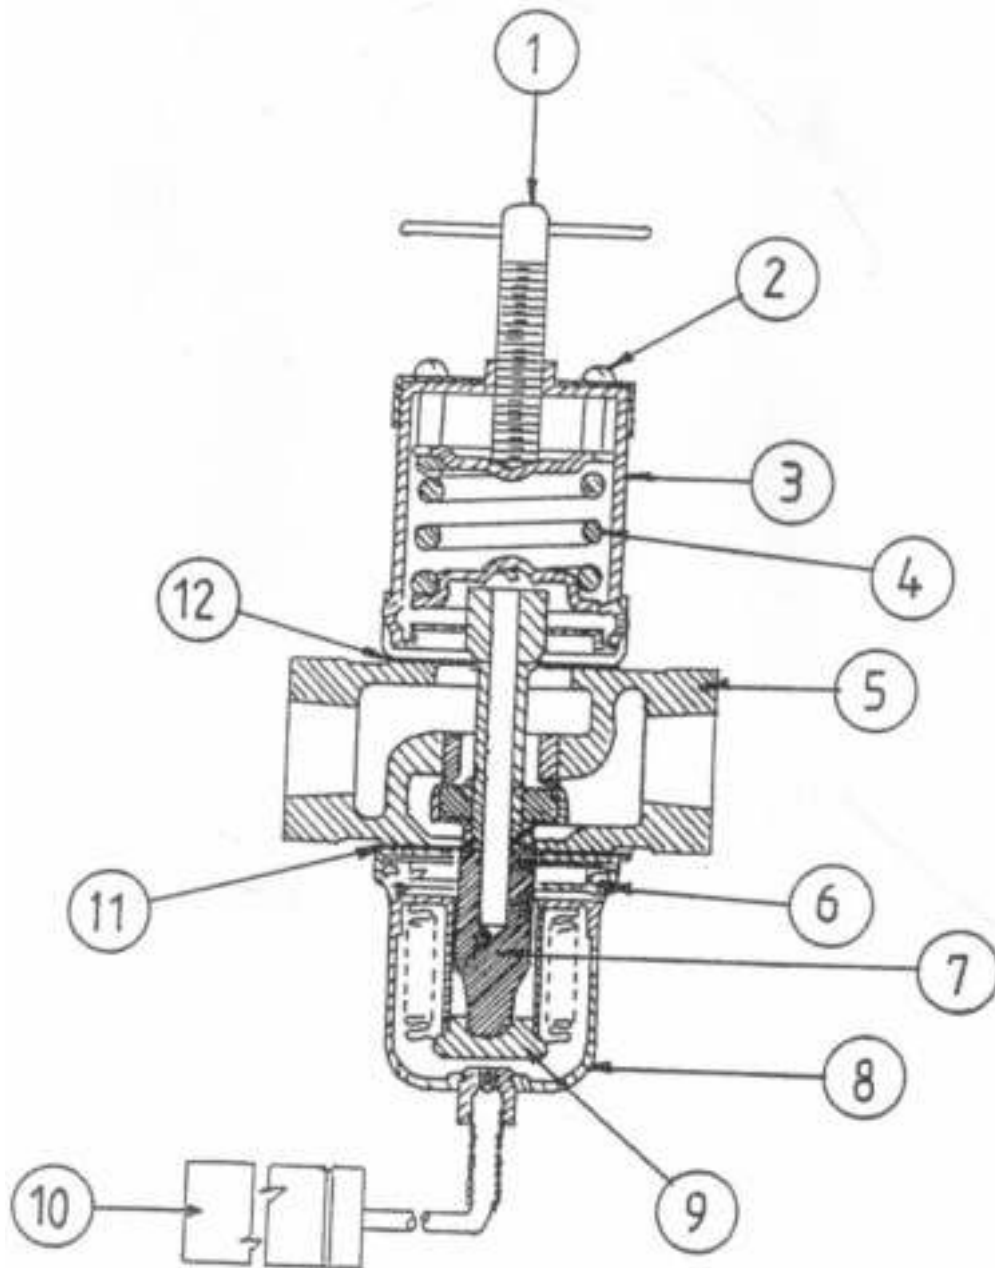
MODULATING VALVE

The power element (10) usually needs to be replacing when it is not possible to control the heat of the dryer with the modulating valve.

Remove the four screws which secure the power element bellows (8) and carefully withdraw the bellows from the main body of the valve. Take care not to lose the reinforcing plate (9).

Fit the bellows (8) of the new power element to the main body of the valve, ensuring that the reinforcing plate (9) is in position. Carefully thread the power element sensor and tube through the tube into the plenum chamber and fit the new sensor into the bracket and secure it to the frame. Carefully coil up and/or secure any excess capillary tube so it cannot get accidentally damaged.

To reset the valve, screw in the adjusting screw (1) until pressure is felt the screw in a further 4 full turns. Make the final adjustment with the burner running.

REPLACING THE POWER ELEMENT ON A MODULATING VALVE:
